# River Mease SSSI/SAC Restoration Plan

Client: Natural England  
Project: River Mease SSSI/SAC Restoration  
Document Title: River Mease SSSI/SAC Restoration Plan

Job No: B1753400

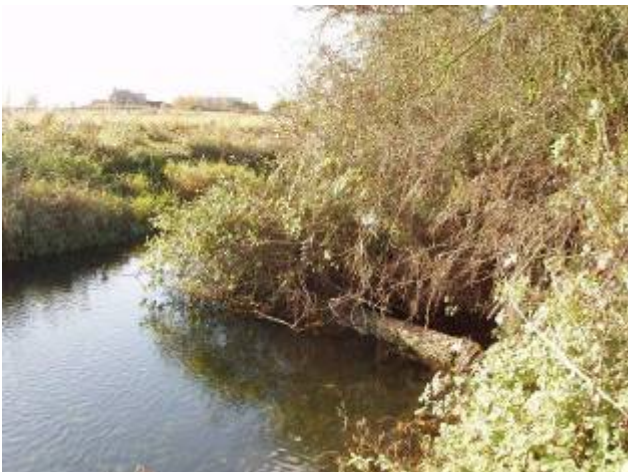
| Woody debris | Category: Restore |
|---|---|
| <p><b>Potential benefits:</b></p> <ul style="list-style-type: none"> <li>Creation of in-channel sinuosity and habitat niches but unlikely to cause significant erosion in a low energy system;</li> <li>Provides small-scale variations in flow velocity providing slower areas of flow and small pools that accumulate finer sediments and act as fish refuges and nursery sites, spawning habitat for bullhead;</li> <li>Creates areas of cover and shading that can reduce predation of fish, but also provide foraging sites for terrestrial species such as otter;</li> <li>Valuable invertebrate and algae habitats, creating food sources for fish, helping to sustain aquatic/terrestrial food chain;</li> <li>Helps regulate sediment transfer and water quality by temporary trapping of mobile silts, reducing siltation of shallower gravels/riffles and turbidity;</li> <li>Introduced river gravels with woody debris improves bed structure, flow variation and habitat diversity.</li> </ul> | <p><b>Concept of introduced woody debris to create sinuosity/variability of flow in a straight section of channel</b></p> <p><b>Example of fallen tree creating some variation and habitat cover in an over-wide/over-deep section of the River Mease</b></p> |

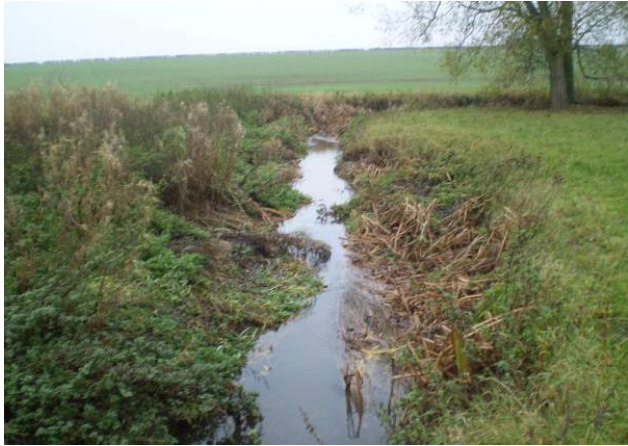
| Bank re-profiling | Category: Restore |
|---|---|
| <p><b>Description:</b></p> <ul style="list-style-type: none"> <li>Where banks have been steepened, through either channel deepening or straightening, the variety of marginal habitats will be reduced and flow within the channel is made faster and more uniform;</li> <li>Banks can be re-profiled (to make them less steep) to allow areas of marginal vegetation to develop.</li> <li>Removal of material from the bank to form a more gently sloping bank face;</li> <li>Shallow bank slopes typically occur on the inside of meanders. The extensive re-sectioning/deepening that has occurred along the River Mease in the past, means that often the banks on the inside of bends are steep. These areas should be prioritised for re-profiling.</li> <li>The actual slope of the bank will depend upon its location and will need to be confirmed during the production of a detailed design. Providing a range of bank slopes will provide diverse channel morphology to be created.</li> </ul> | <p><b>Illustration:</b></p> <p><u>R4 Re-profile bank to reduce slope</u></p> <p>Bank profile prior to restoration (dashed)</p> <p>Lower inside of bend</p> <p><b>Example of natural channel narrowing on the River Mease in the foreground. The bank profile is less steep and vegetation encroaches into channel. This contrasts with the bend in the distance where the bank remains high and could be improved by re-profiling.</b></p> |

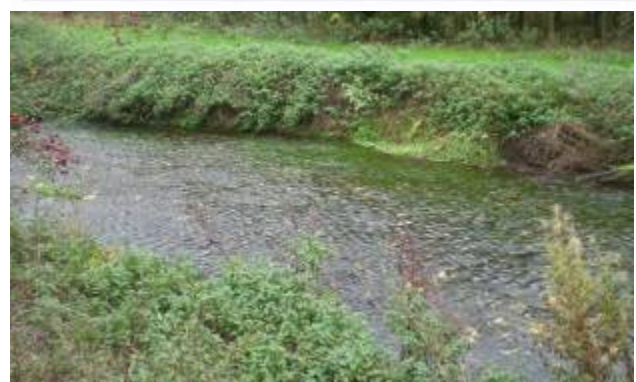
| Bed raising / riffle creation | Category: Restore |
|---|---|
| <b>Description:</b> <ul style="list-style-type: none"> <li>Gravel can be used to raise the river bed slightly at suitable locations within over-deepened channels, to create areas of flow variation in terms of speed, depth and direction;</li> <li>Choosing a suitable gravel size is ecologically important, and also to ensure it is reasonably stable in higher flows;</li> <li>Riffles can also be shaped to create a slightly narrower sinuous low flow channel. This means that during low flows the flow does not become too diffuse. This also creates areas of variation at low flow.</li> <li>In some situations riffles can form naturally in response to bank erosion and increasing channel sinuosity or channel widening. However this requires an adequate supply of coarse sediment (gravel) and flow velocities sufficient to transport this material (e.g. Gilwiskaw Brook and upper River Mease). Riffles are less likely to develop without help where the channel gradient is low and the supply of coarse sediment is limited in the middle and lower reaches of the River Mease (downstream of Stretton Bridge).</li> <li>Should be undertaken in conjunction with bank re-profiling (R4).</li> </ul> | <b>Illustrations:</b><br>Riffle in planform shown at low flow (at normal and high flow the riffle will be completely submerged): <br>Effect of narrowing the channel at low flow: <br>Long-section (creating areas of shallower flow across riffle and deeper flow up and downstream): <br><br><b>Example riffle on River Mease with shallow flow creating disturbance to water surface and some <i>ranunculus</i> beds present</b> |

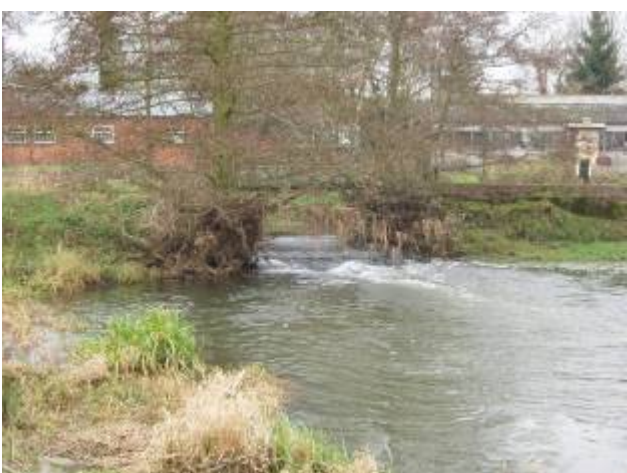
| Remove Weir | Category: Restore | |
|---|---|--|
| <b>Potential benefits:</b> <ul style="list-style-type: none"><li>• Allows more natural water level variations upstream (reduces deep water from impoundment);</li><li>• Enables natural downstream sediment transport and reduces upstream silt smothering of river bed caused by impoundment;</li><li>• Allows the development of more varied flow types upstream of the former structure, increasing habitat variety including potential areas suitable for <i>ranunculus</i> and other macrophytes;</li><li>• Allows the river channel morphology to respond and adjust to changes in flow and sediment supply, creating diverse channel morphology;</li><li>• Removes barriers or obstacles to bullhead, spined loach and other fish movement through the river system between suitable local habitats.</li></ul> | <br><b>Weir on the River Mease at Clifton Campville, impounding flow upstream and significant scour pool downstream</b> | |

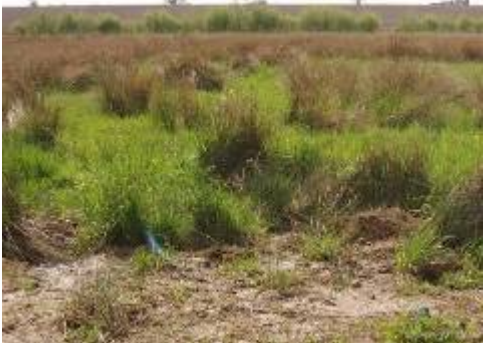
| <b>Description:</b> <ul style="list-style-type: none"> <li>Creation of areas of wetland can help to provide links between aquatic and terrestrial habitats as part of a functioning lowland river-floodplain ecosystem, and also help with water quality and sediment management issues;</li> <li>This can be achieved by creating floodplain scrapes to create <u>wet areas in the floodplain</u>, targeted at areas that show signs of poor drainage;</li> <li>Alternatively by lowering banks to widen field ditches or small tributaries at their confluence with the main river, creating <u>marginal reed beds</u> or <u>areas of wet woodland</u> to trap sediment at high flow. This is likely to be required where ditches are relatively deep.</li> <li>Some planting of suitable wetland species may be required if natural recolonisation is unlikely.</li> </ul> | <b>Illustration:</b><br><u>Wet areas on floodplain</u><br><br><b>Area of poorly draining rush pasture, which could be enhanced in areas close to the channel to create a more varied and functional wetland</b> |

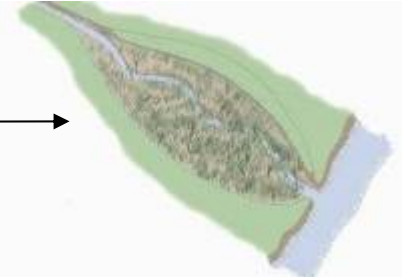
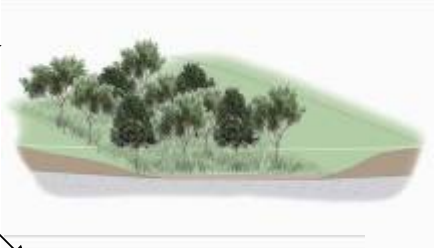
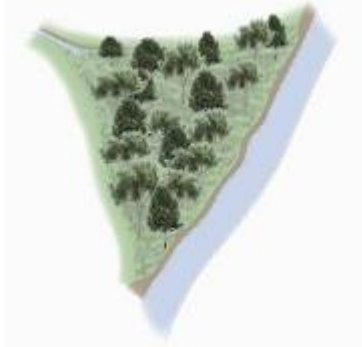
| <b>Illustration: <u>Widen tributaries to create marginal reed beds or wet woodland</u></b><br>Initial condition: <div style="display: flex; justify-content: space-around; align-items: flex-start;"> <div style="text-align: center;"> <p>↓</p> <p><u>Marginal reed beds</u><br/>Widen and slightly deepen channel and create low, waterlogged ledges along the margins of a narrow low flow channel</p> </div> <div style="text-align: center;"> <p>→</p> <p><u>Wet woodland</u><br/>Widen and slightly deepen channel and create low lying area of wetland and wet woodland.</p> </div> <div style="text-align: center;"> <p>→</p> </div> </div> <div style="text-align: center; margin-top: 20px;"> </div> | |

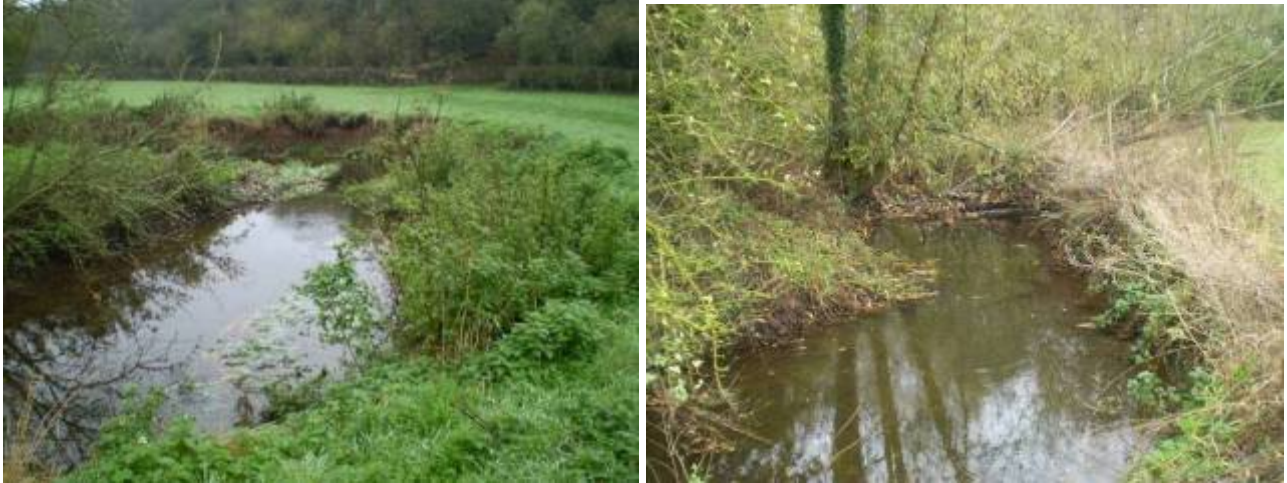
| Description | Photographs |
|---|---|
| <p><b>Reach GIL007</b> Start NGR 434047 310411 End NGR 433656 310072</p> <p><b>Key features:</b></p> <ul style="list-style-type: none"><li>Meandering section showing evidence of adjustment and recovery towards a more typical morphology, through localised bank erosion and deposition (gravel point bars), which is leading to the development of a highly varied channel morphology (pools and riffles).</li><li>Supply of coarse woody debris, which when located in the channel adds to flow diversity and the creation of microhabitat patches.</li></ul> <p><b>Conservation actions:</b></p> <ul style="list-style-type: none"><li>Improve the riparian zone, particularly along the right bank. This should involve creating a strip of natural riparian vegetation parallel to the bank top.</li></ul> | |

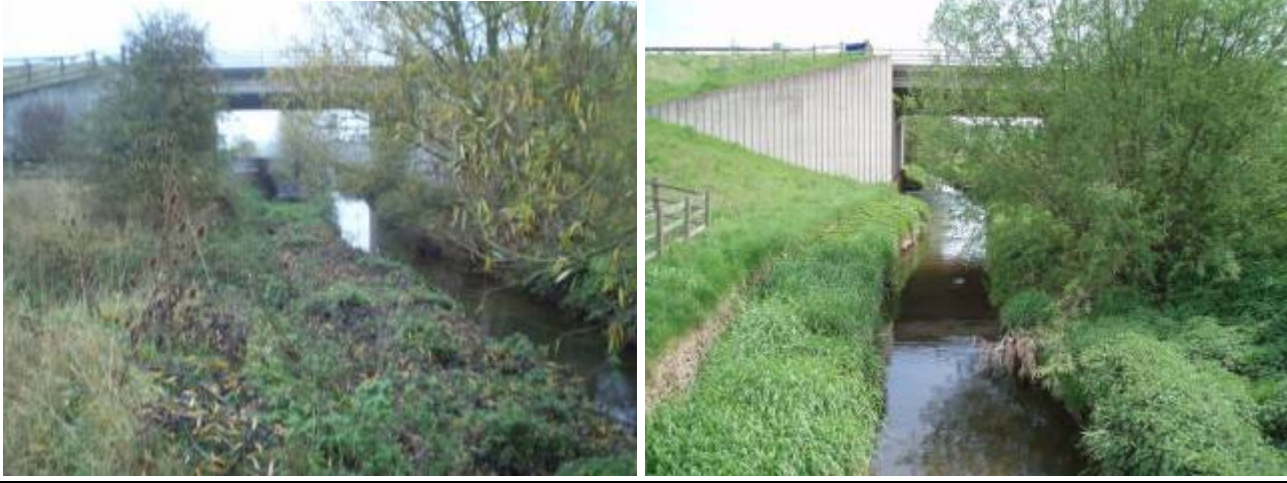
| Description | Photographs |
|---|---|
| <p><b>Reach MEA006</b> Start NGR 431527 311949 End NGR 431459 312042</p> <p><b>Key features:</b></p> <ul style="list-style-type: none"><li>Highly modified section of channel passing beneath the A42 trunk road.</li><li>The channel has been straightened and substantially over-widened.</li><li>However, it has now adjusted towards a more natural channel form through narrowing following the deposition of sediment along the banks and subsequent colonisation by vegetation including some trees.</li></ul> <p><b>Conservation actions:</b></p> <ul style="list-style-type: none"><li>Due to the constraints in this location (trunk road and access routes) it is unlikely that the channel can be further improved. Attention should focus on preventing actions which may degrade the channel (e.g. vegetation clearance or dredging).</li></ul> | |

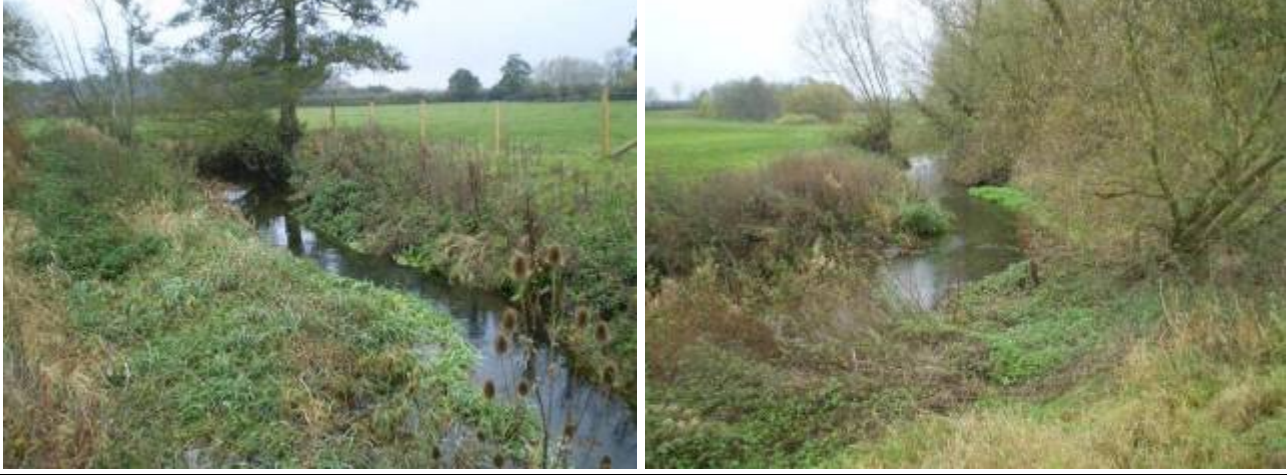
| Description | Photographs |
|---|---|
| <p><b>Reach MEA009</b> Start NGR 428674 312761 End NGR 427658 311984</p> <p><b>Key features:</b></p> <ul style="list-style-type: none"><li>Evidence of adjustment and recovery, through narrowing as a result of marginal sediment deposition and colonisation of deposits by vegetation, which is leading to the development of varied channel morphology (range of flow velocities).</li><li>Channel banks and margins have good vegetation cover indicating little erosion or disturbance of the banks.</li></ul> <p><b>Conservation actions:</b></p> <ul style="list-style-type: none"><li>Increase the width of the riparian zone along both banks. This should involve creating a corridor of natural riparian vegetation. The riparian zone should encompass the floodplain on the inside of meanders.</li></ul> | |

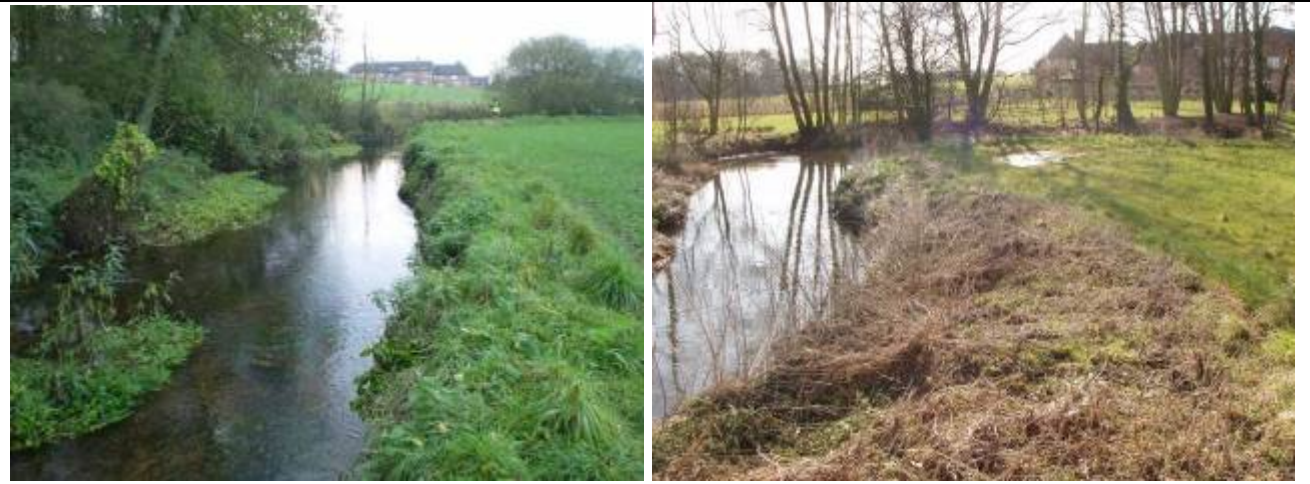
| Description | Photographs |
|---|---|
| <p><b>Reach MEA012   Start NGR 2426814 311073   End NGR 426197 311465</b></p> <p><b>Key features:</b></p> <ul style="list-style-type: none"> <li>• Meandering section of river with a natural planform undergoing adjustment, through narrowing as a result of marginal sediment deposition and colonisation of deposits by vegetation.</li> <li>• Localised sediment deposition on the bed creates occasional riffles.</li> <li>• Channel banks and margin have good vegetation cover.</li> </ul> <p><b>Conservation actions:</b></p> <ul style="list-style-type: none"> <li>• Restore a corridor of natural riparian vegetation along both banks. The riparian corridor should encompass the floodplain on the inside of meanders.</li> </ul> | |

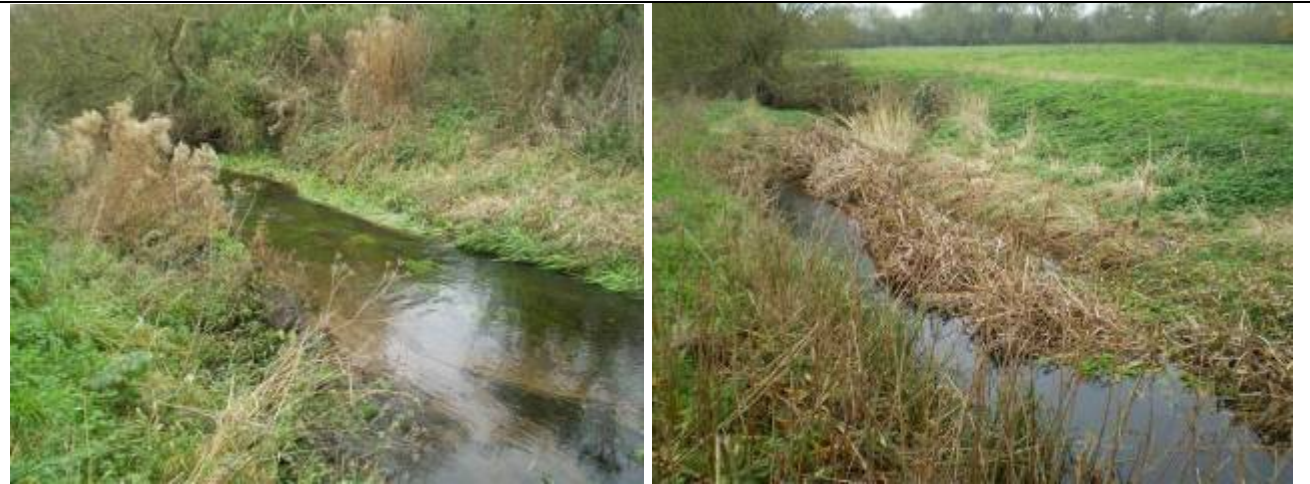
| Description | Photographs |
|---|---|
| <p><b>Reach MEA014   Start NGR 425232 311450   End NGR 423819 311368</b></p> <p><b>Key features:</b></p> <ul style="list-style-type: none"> <li>• Meandering section of channel which is located along the valley side in a number of sections.</li> <li>• Evidence of natural adjustment, through narrowing as a result of marginal sediment deposition and colonisation of deposits by vegetation.</li> <li>• Localised sediment deposition on the bed has created a number of shallow riffles which have been colonised by <i>Ranunculus</i>.</li> <li>• Channel banks and margin have good vegetation cover.</li> </ul> <p><b>Conservation actions:</b></p> <ul style="list-style-type: none"> <li>• Create a corridor of natural riparian vegetation along both banks.</li> </ul> | |

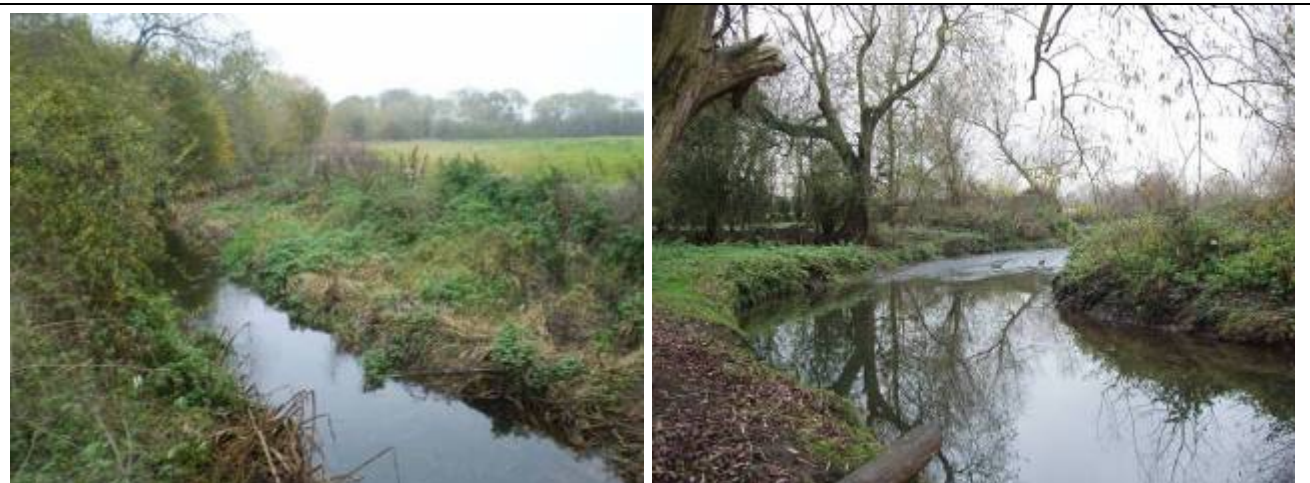
| Description | Photographs |
|---|---|
| <p><b>Reach MEA015   Start NGR 423819 311368   End NGR 423368 311366</b></p> <p><b>Key features:</b></p> <ul style="list-style-type: none"> <li>• Evidence of adjustment, through narrowing as a result of marginal sediment deposition and colonisation of deposits by vegetation.</li> <li>• Localised sediment deposition on the bed has created a number of shallow riffles which have been colonised by <i>Ranunculus</i>.</li> <li>• Channel banks and margin has good vegetation.</li> </ul> <p><b>Conservation actions:</b></p> <ul style="list-style-type: none"> <li>• Create a corridor of natural riparian vegetation along both banks.</li> <li>• Manage livestock access to the channel (there is currently a small drinking point on the right bank) either through fencing or by providing livestock operated drinkers.</li> </ul> | |

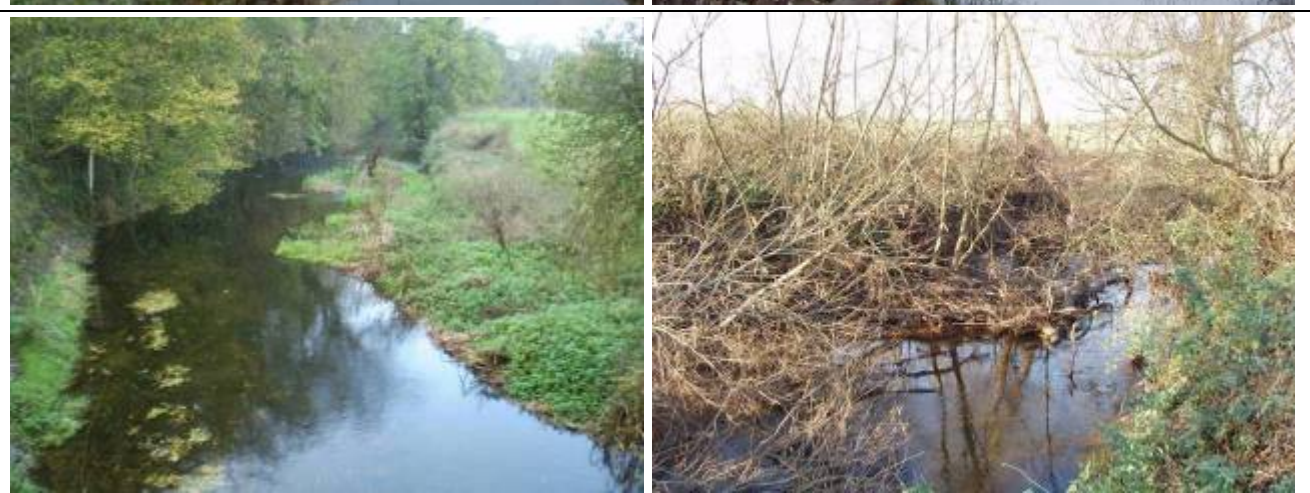
| Description | Photographs |
|---|---|
| <p><b>Reach MEA018   Start NGR 412503 311167   End NGR 421419 311505</b></p> <p><b>Key features:</b></p> <ul style="list-style-type: none"> <li>• Section of channel which is located along the left side of the valley.</li> <li>• Evidence of adjustment, through narrowing and localised sediment deposition on the bed which has created a number of shallow riffles.</li> <li>• Good supply of coarse woody debris that creates to flow diversity and microhabitat patches.</li> </ul> <p><b>Conservation actions:</b></p> <ul style="list-style-type: none"> <li>• Encourage development of natural riparian vegetation along the right bank.</li> </ul> | |

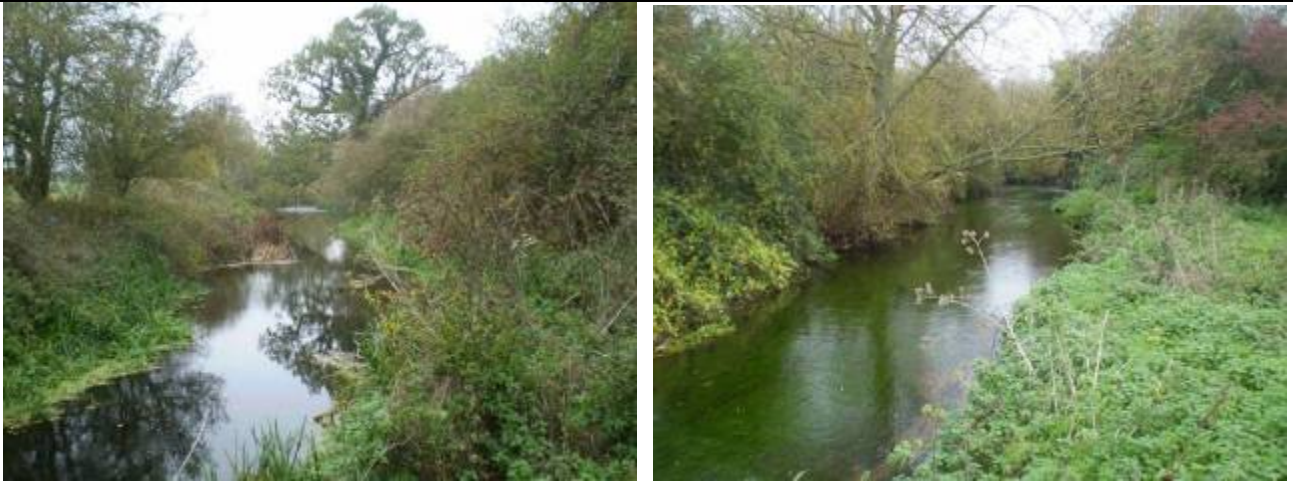
| Description | Photographs |
|---|---|
| <p><b>Reach MEA022   Start NGR 420229 312590   End NGR 419685 313057</b></p> <p><b>Key features:</b></p> <ul style="list-style-type: none"> <li>• Located along the valley side in the upper part of the reach.</li> <li>• Has adjusted towards a more natural form through narrowing as a result of marginal sediment deposition and colonisation of deposits by vegetation.</li> <li>• Localised sediment deposition on the bed has created a number of shallow riffles which have been colonised by <i>Ranunculus</i>.</li> <li>• Channel banks and margins have good vegetation cover.</li> <li>• Good supply of coarse woody debris.</li> </ul> <p><b>Conservation actions:</b></p> <ul style="list-style-type: none"> <li>• While the riparian vegetation generally natural and diverse there are some gaps which could be filled.</li> </ul> | |

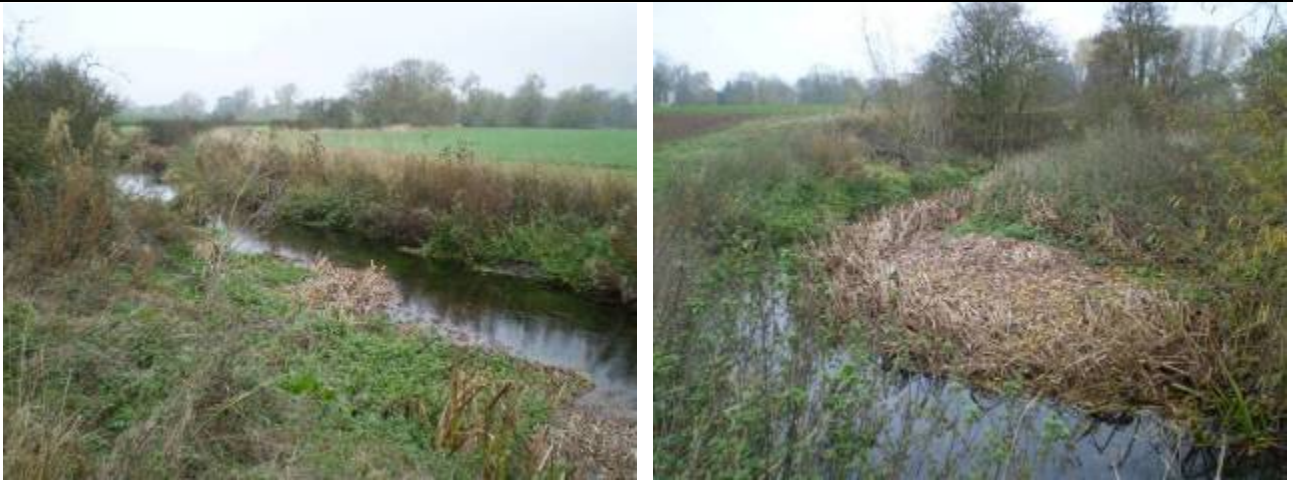
| Description | Photographs |
|---|---|
| <p><b>Reach MEA023   Start NGR 419685 313057   End NGR 419814 313486</b></p> <p><b>Key features:</b></p> <ul style="list-style-type: none"> <li>• Meandering section of river with a natural planform undergoing adjustment, through narrowing as a result of marginal sediment deposition and colonisation of deposits by vegetation.</li> <li>• The varied channel width has created varied flow velocities.</li> <li>• Channel banks and margins have good vegetation cover.</li> </ul> <p><b>Conservation actions:</b></p> <ul style="list-style-type: none"> <li>• The land along both banks is arable and the uncultivated margin is relatively narrow in places. The width of the uncultivated margin could be increased by restoring a strip of natural riparian vegetation at least 12m wide along both banks.</li> </ul> | |

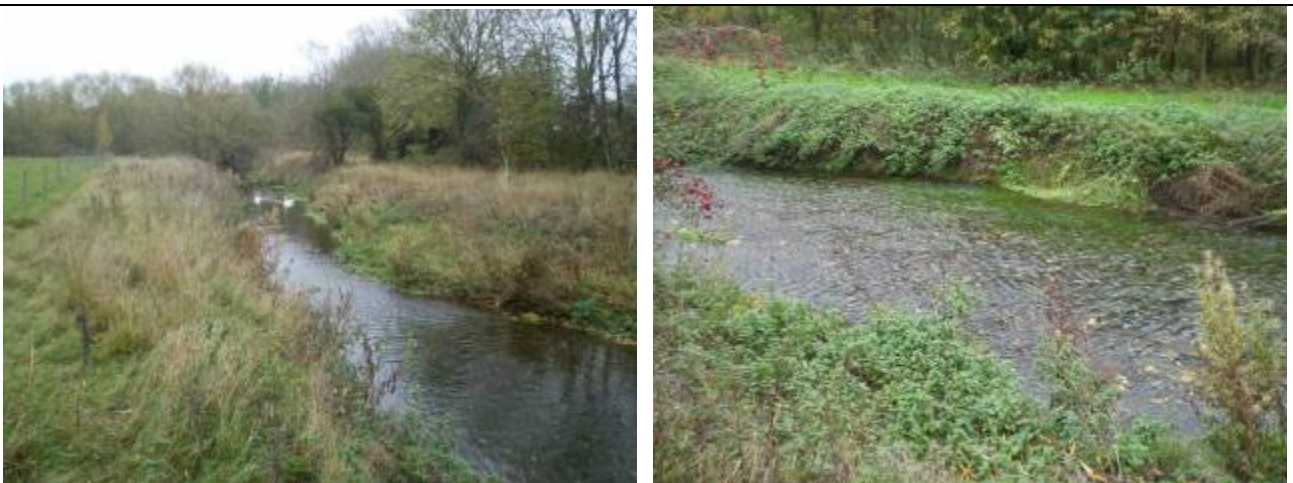
| Description | Photographs |
|---|---|
| <p><b>Reach MEA025   Start NGR 419283 314020   End NGR 419528 314739</b></p> <p><b>Key features:</b></p> <ul style="list-style-type: none"> <li>• Previously realigned section of river, which has a relatively straight planform with occasional bends. However, despite this modification the channel has a highly varied morphology.</li> <li>• Evidence of adjustment, through narrowing as a result of marginal sediment deposition and colonisation of deposits by vegetation.</li> <li>• Localised sediment deposition on the bed has created a number of shallow riffles which have been colonised by <i>Ranunculus</i>.</li> <li>• Channel banks and margins have good vegetation cover.</li> </ul> <p><b>Conservation actions:</b></p> <ul style="list-style-type: none"> <li>• The extent of natural riparian vegetation could be increased along the left bank.</li> </ul> | |

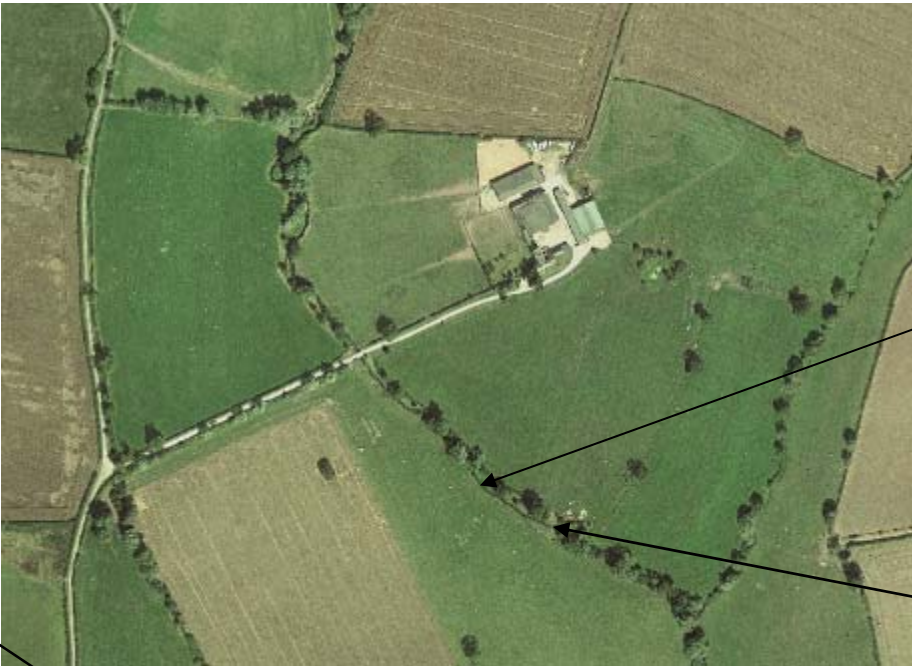
Locations of particularly high rates of bank erosion

**Action E2**  
Create a corridor of natural riparian vegetation along (parallel to) both banks along the full length of the reach. This should ideally be at least 12m wide along both sides of the channel. Tree planting will be required and a way to control stock access until the riparian vegetation has established will be required.

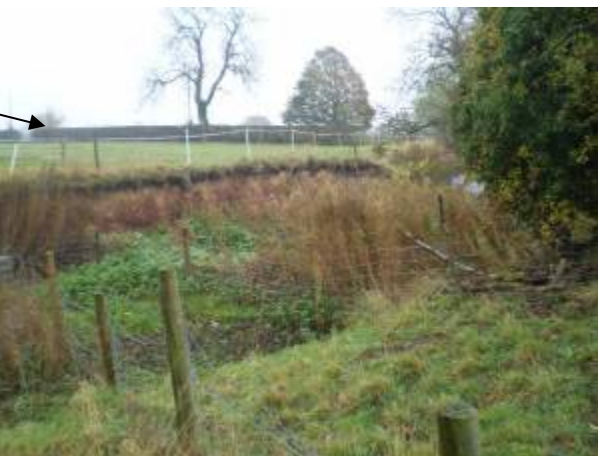
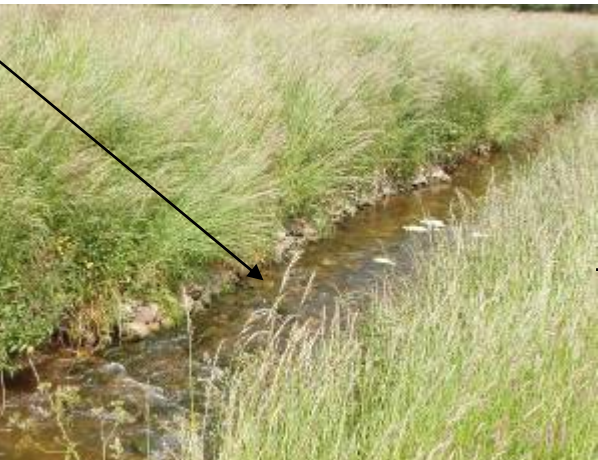
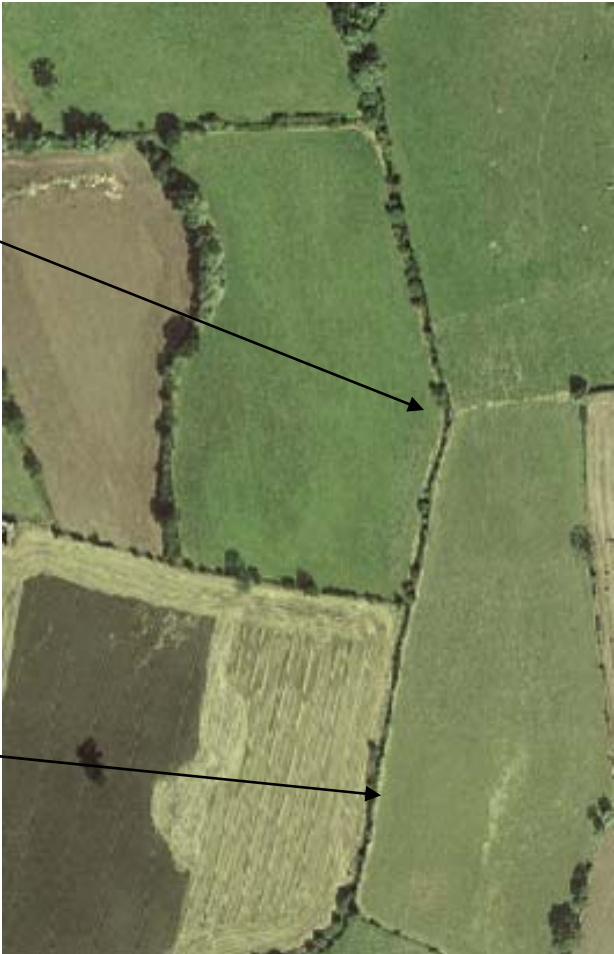
**Action R2 and R4**  
Remove stone bank reinforcement and re-profile the banks to reduce the bank slope.

| Action | Site specific details (refer also to Section 3) | Site specific benefits (refer also to Section 3) | Site specific constraints |
|---|---|---|---|
| Remove bank reinforcement and re-profile the banks | Remove the stone bank reinforcement along both banks in the middle section of the reach and re-profile the banks to reduce the bank slope. | Would restore natural bed (cobble/gravel) and bank (earth) conditions. | None Identified. |

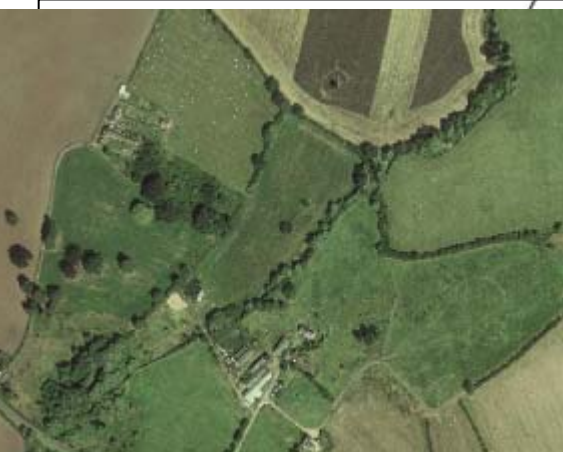
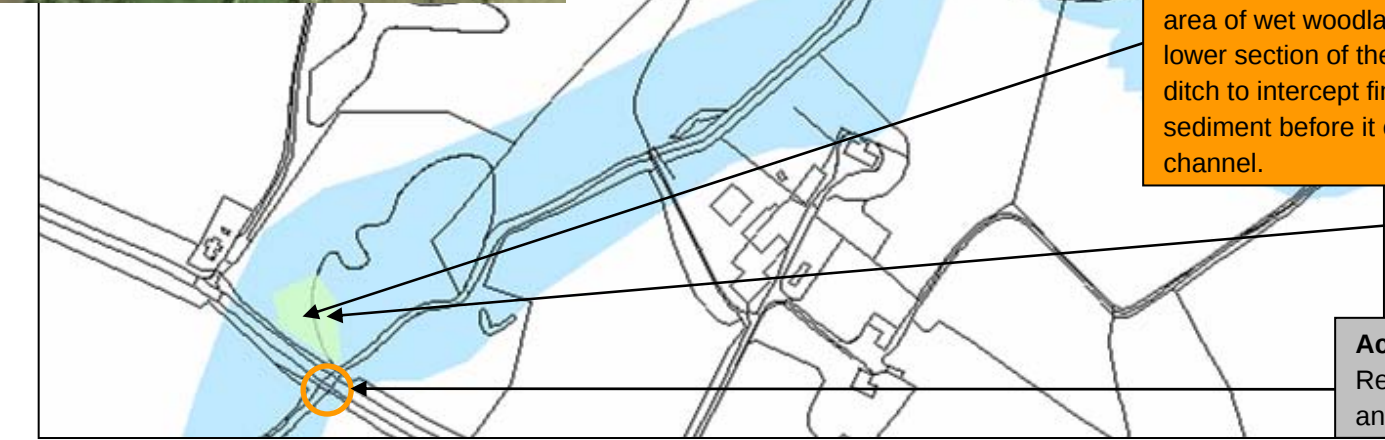
Restoration actions (upstream of Swebstone Road):

**Action R2**  
Remove culvert and reinstate a natural section of tributary channel.

**Action R7**  
In-fill the drain and plant an area of wet woodland at the lower section of the drainage ditch to intercept fine sediment before it enters the channel.

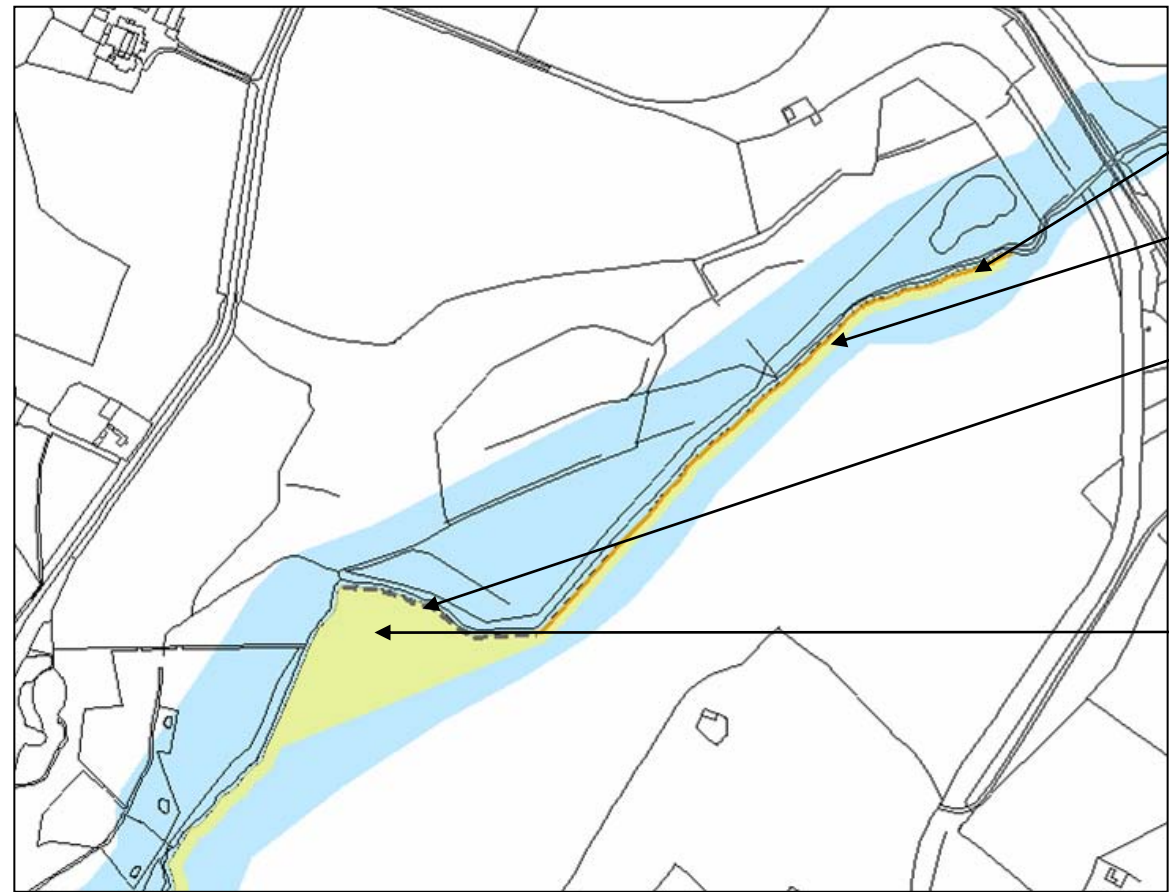
Action R4

Re-profile left bank to reduce the slope of the left bank.

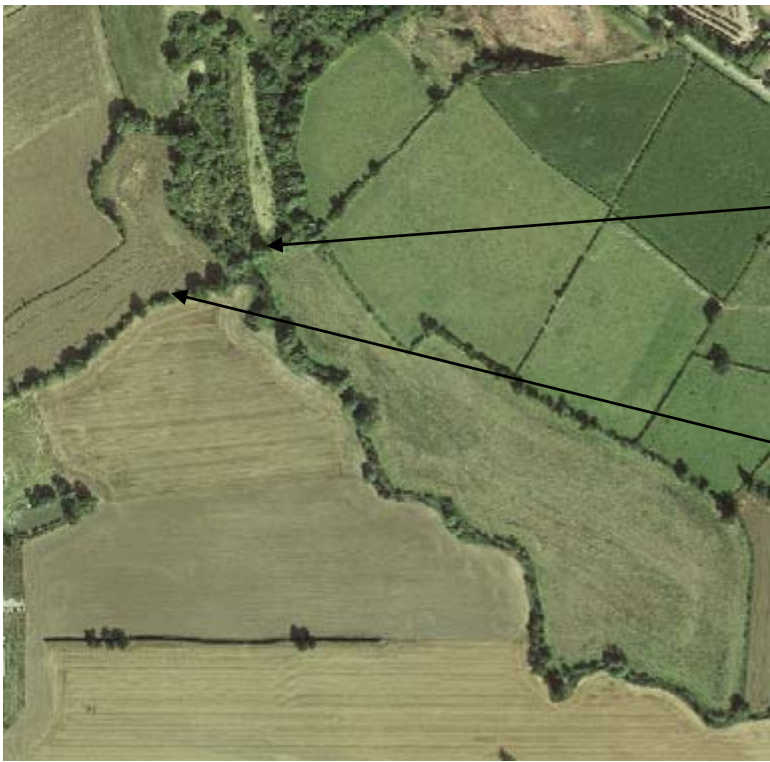
**Action R7**  
Create areas of wet woodland near the confluence of the open drains (ditches) to the left and right of the channel and divert discharge from drains through this woodland.

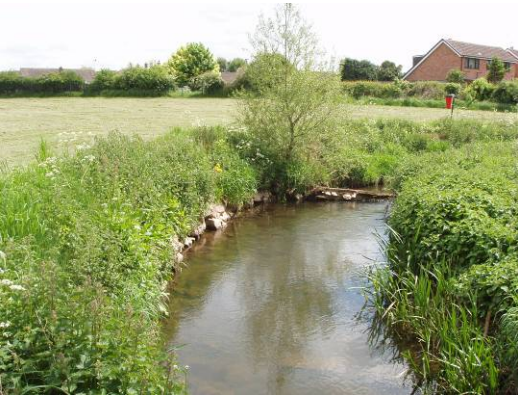
**Action E3**  
Create a riparian corridor along the channel. As this is a low lying area which is at risk of flooding, opportunities should be sought to maximise the extent of this in the core of meanders to reduce the risk of soil erosion during floods.

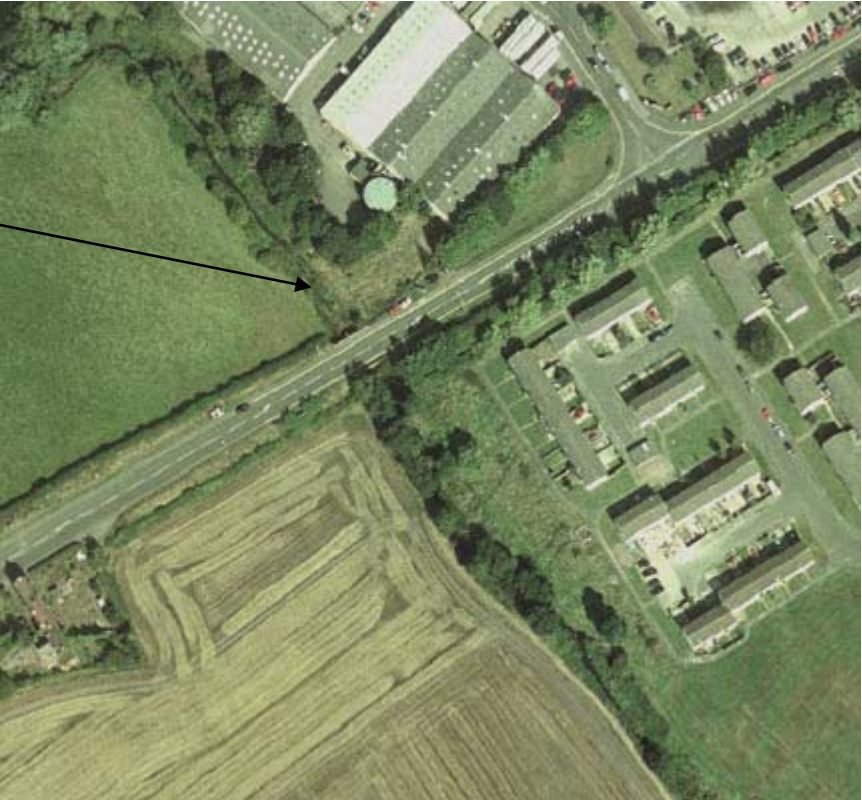
**Action R1**  
Introduce woody debris along reach.

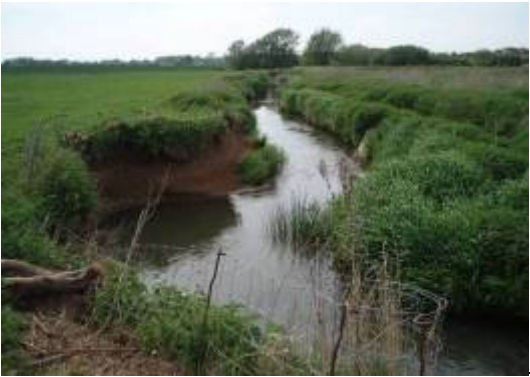
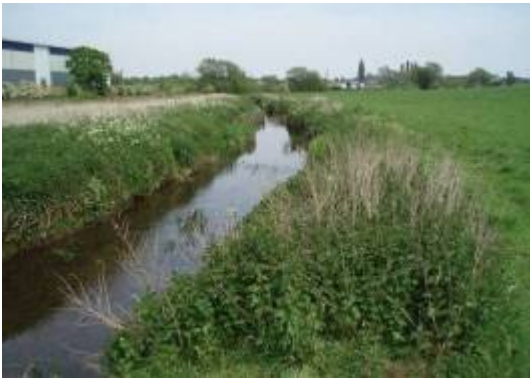
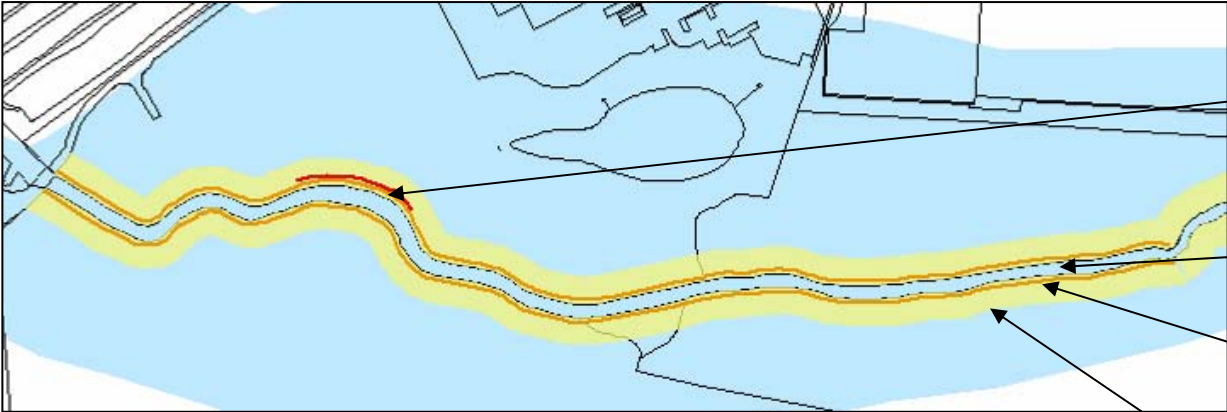
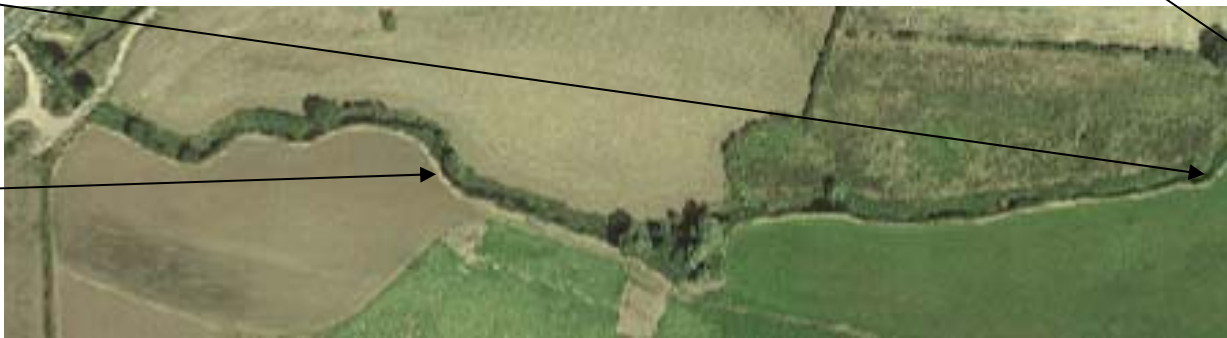
**Action R2**  
Remove rock armour bank protection.

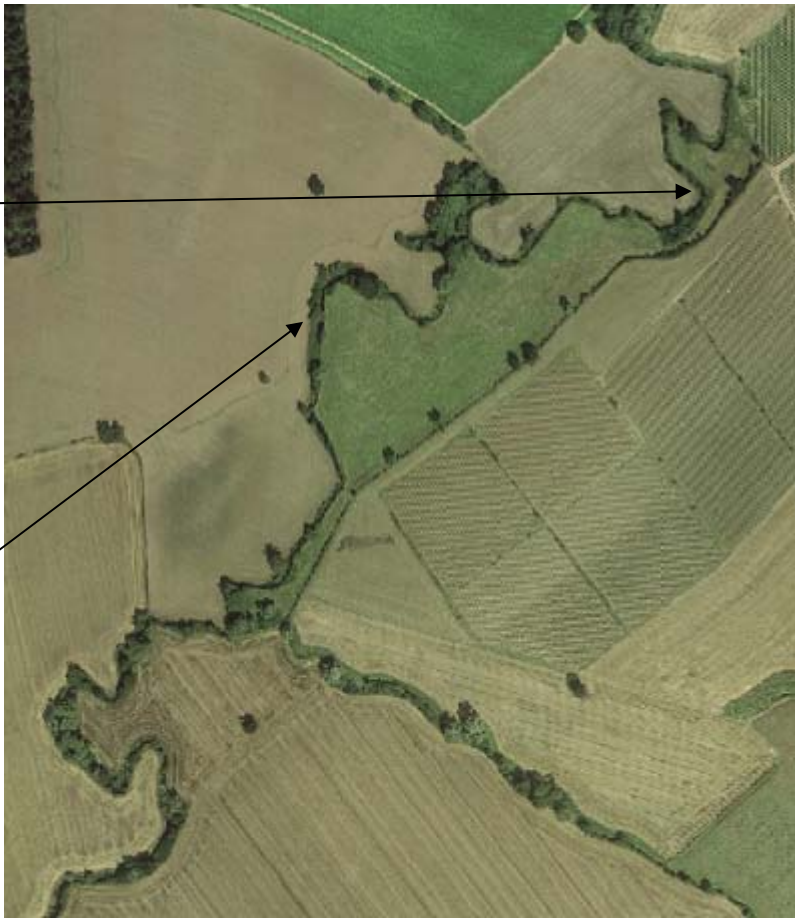
**Action E3**  
Create a riparian corridor of along both banks along the full length of the reach. This should be ideally at least 12m wide along both sides of the channel. The riparian corridor should include the inside of the meanders in the channel to reduce the risk of soil erosion.

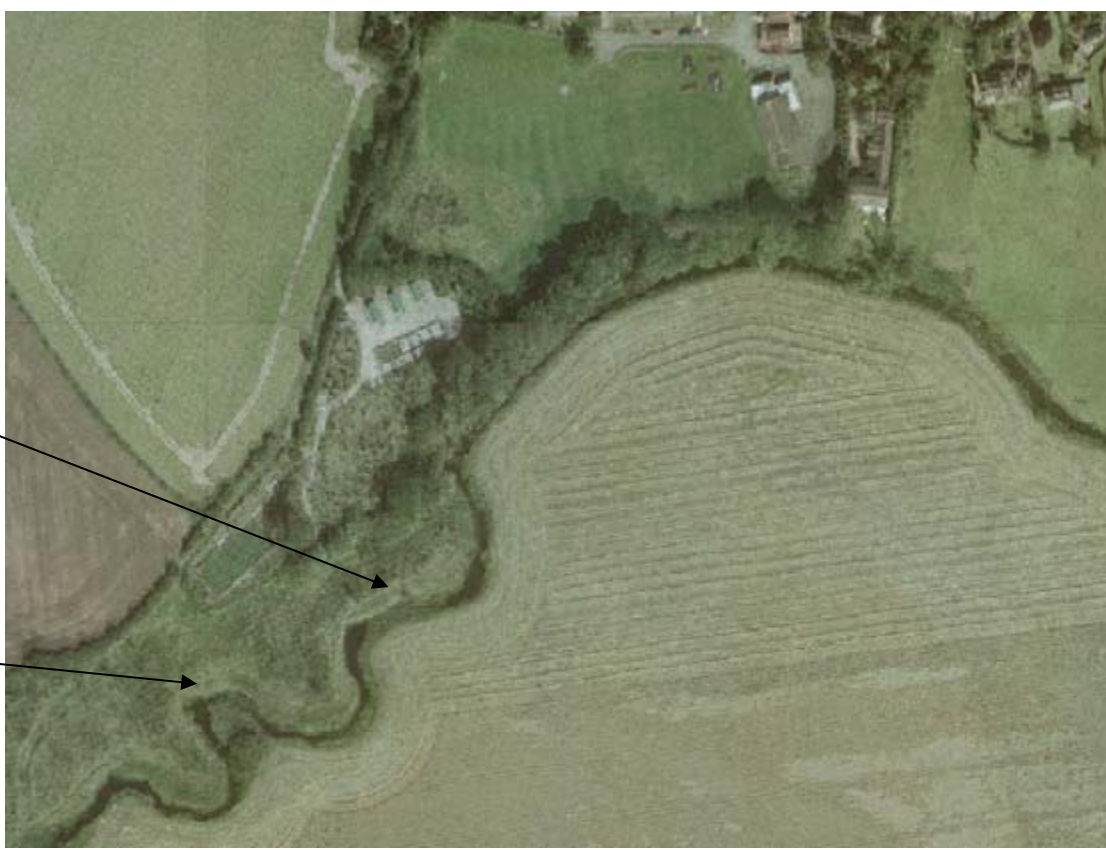
**Action E3**  
Create a riparian corridor along the left bank. This should be ideally at least 12m wide along both sides of the channel.

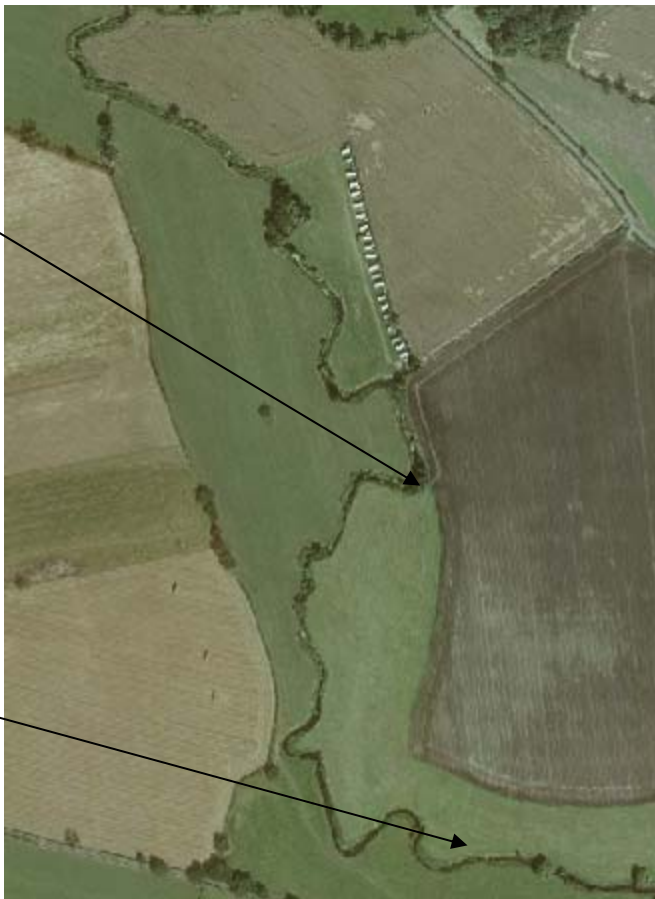
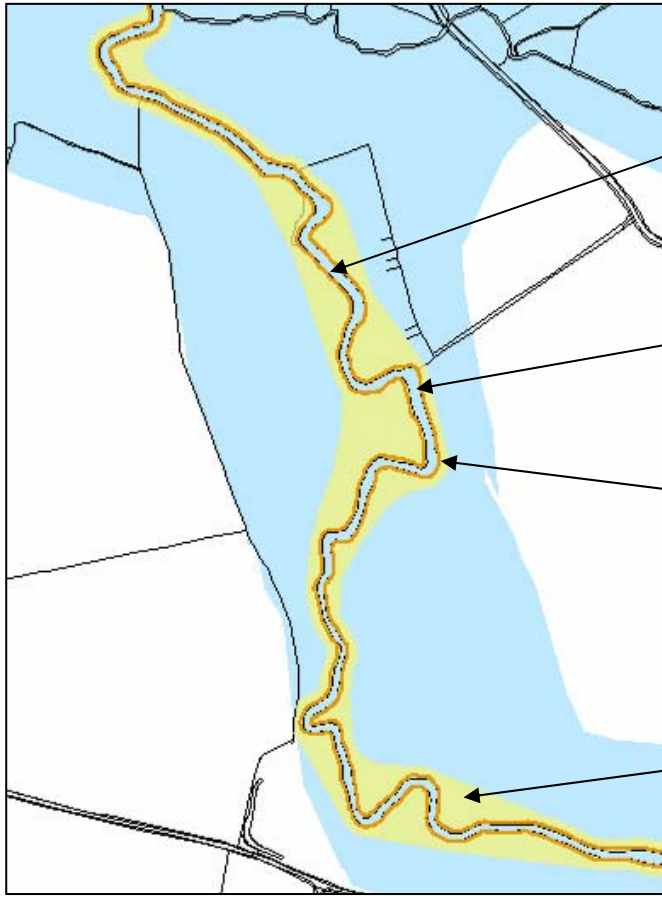
**Action R4**  
Re-profile banks to create a variety of bank profiles along the full length of the reach.
